Manhole Inspection Summary

Manhole # S21K__045MH

Insp Date: **9/25/07 11:20 AM**

Location Address: **233 FULTON-BRUCE**

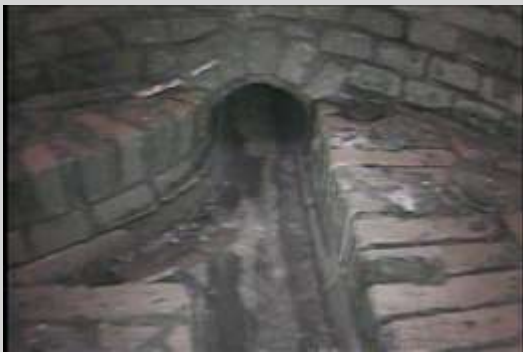
12 O'Clock Outflow

8 in. Circular Gravity Sewer
Pipe Out @ 12 O'Clock

Pipe Height: **8.4** (in.) Rod and Bar (Angled)
Pipe Material: **Clay** ☐ Pipe Lined
Invert Depth: **14.01** (ft.) Flow Characteristics: **Slow**
Deposits: ☒ None ☐ Mud ☐ Sludge ☐ Debris ☐ Grease
Silt Depth: (in.) Deposits Extent:
Infiltration: **None** Pipe Seal Cond: **Sound**
